# SALTSJÖ JÄRLA

**Description & Objectives:** Identify daylight potential at an early design stage of a housing building block located in Saltsjö Järila, Stockholm. Evaluation according to building regulation code, BBR.

## Supplementary report

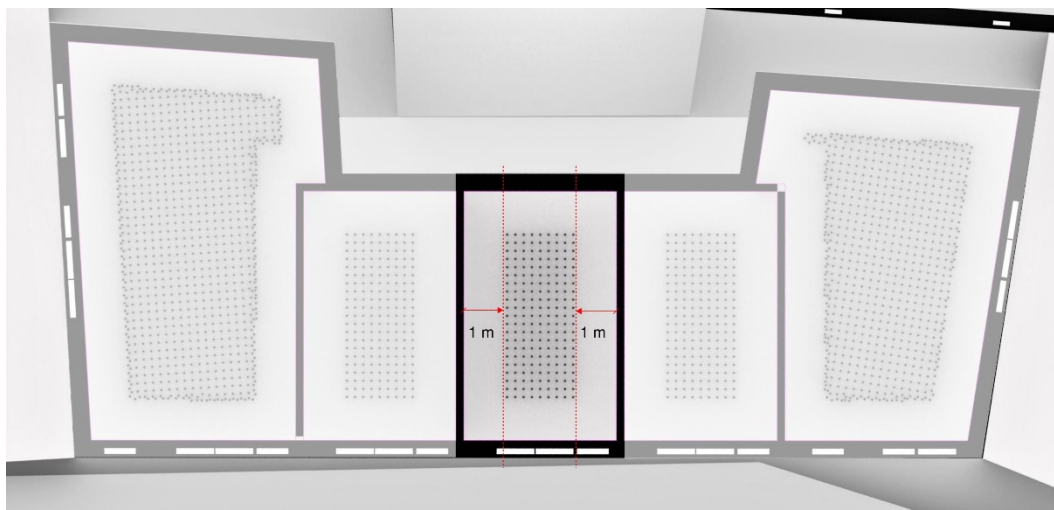
The performance indicator was DFpoint according to BBR (SS 914201,  $DF_p \geq 1\%$ ). Due to the incomplete apartment layout the single DFpoint could not be defined. To overcome this a grid of points spaced  $0.20\text{ m} \times 0.20\text{ m}$  across the apartment area relevant to BBR point was sampled, as shown in Figure 1. When the final apartment layout is decided, the BBRpoint will be located inside this area.

Figure 1. Illustration of the grid points (offset of 1 m from the side walls in order to include the BBR point).

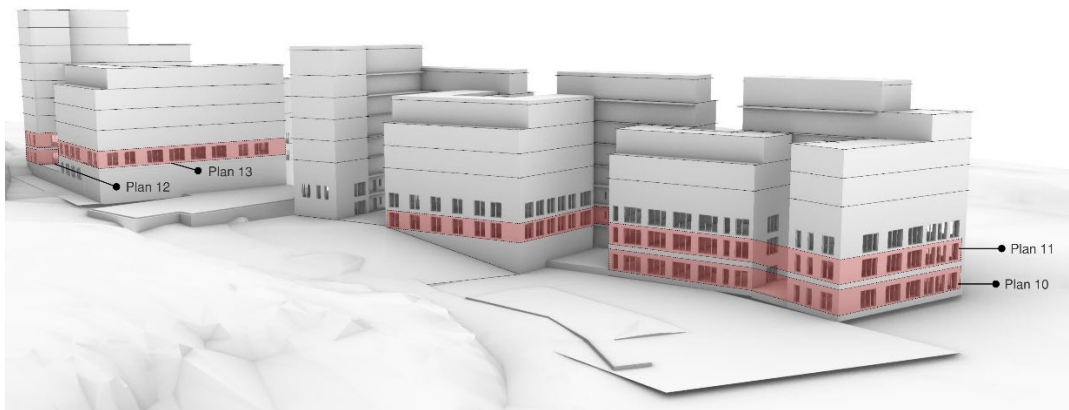
The simulated floors are marked with red color in Figure 2.

Figure 2. The simulated floors (in red).

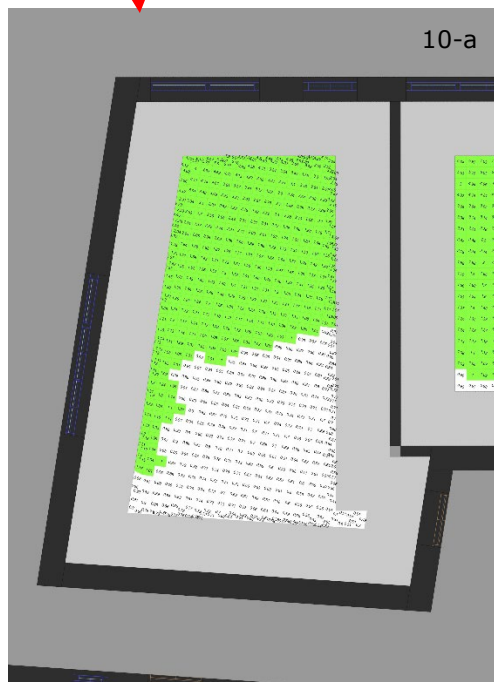
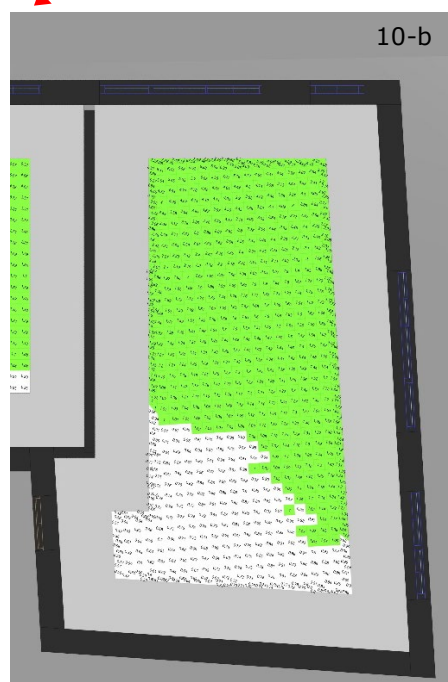
### Plan 10

Green colour indicates the area that has DF at least 1%. White colour indicates the points that the measured DF was lower than 1 %.

10-a & 10-b: DFpoint reached the BBR requirement in the middle of the (whole) depth of both apartments. It is though recommended not to place frequently occupied areas toward south.

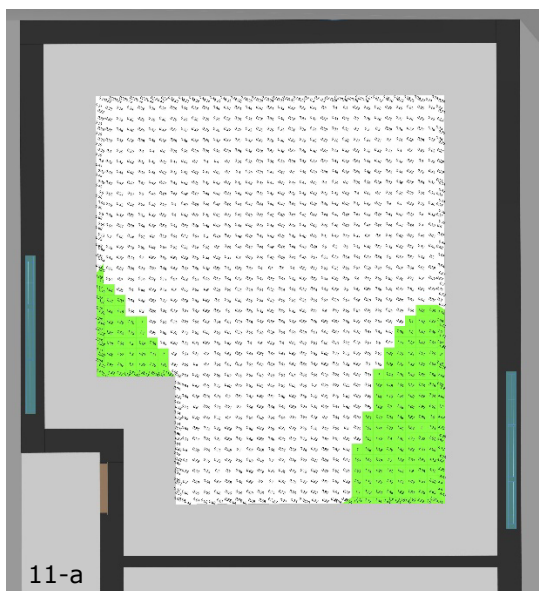
11-a

11-a: Not adequate daylight provision. A north opening is recommended in order to comply with the standard.

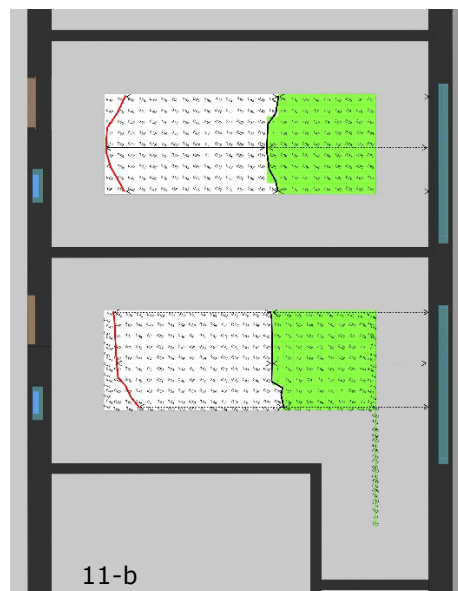
11-b

11-b: The area that has  $DF \geq 1\%$  is shown with green. The red line shows the maximum depth that the room would comply with the BBR (which equals twice the distance of the former line). If hallway and bathroom are placed close to the entrance it will comply with the standard.

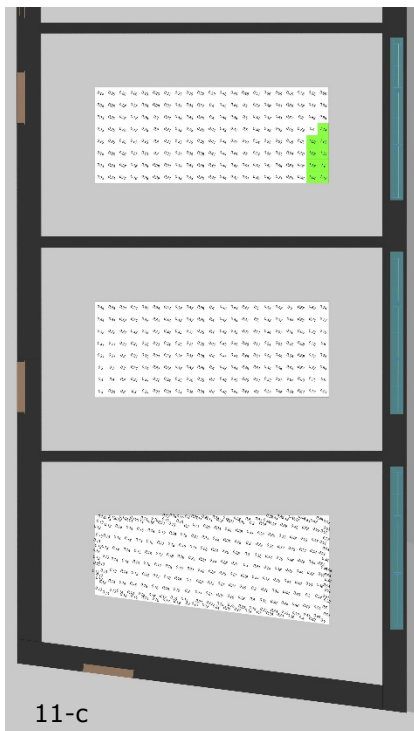
11-c

11-c: All three spaces are considered problematic for daylight provision due to high obstruction. The rooms would not comply with the BBR. A wider atrium might improve the daylight performance.

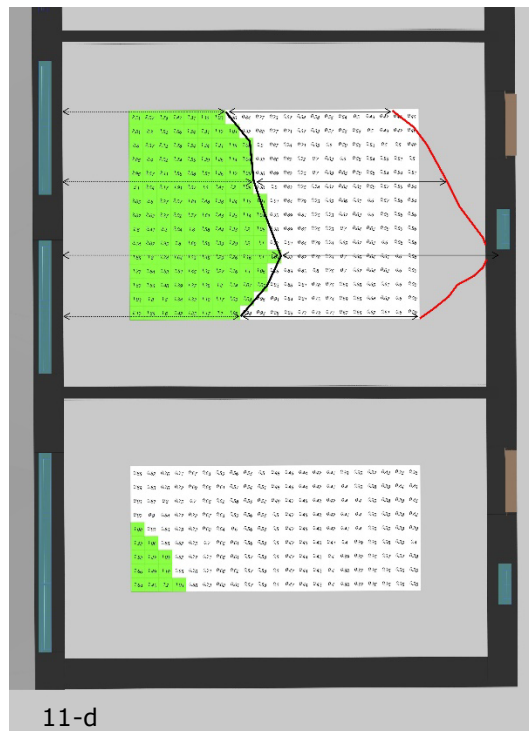
11-d

11-d: The area that has  $DF \geq 1\%$  is shown with green. The red line shows the maximum depth that the room would comply with the BBR. The apartment placed in south does not have adequate daylight provision due to high obstruction.

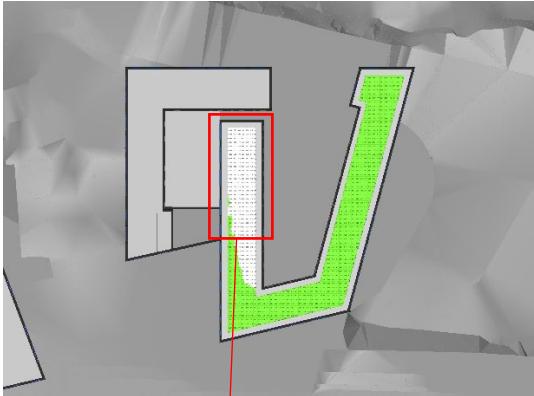
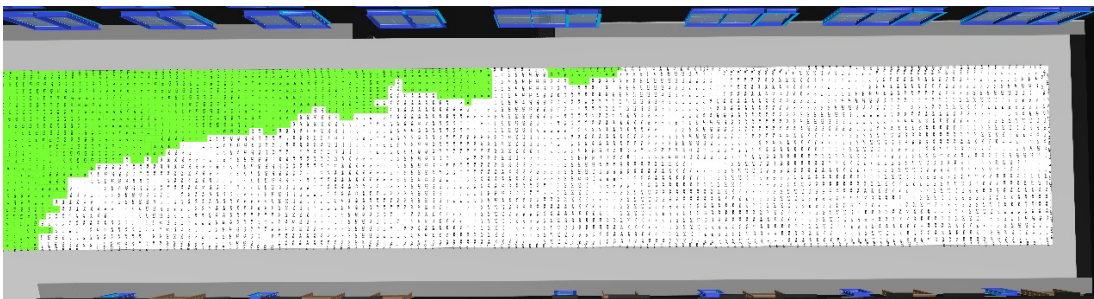
## Plan 12

Problematic in west part due to high obstruction. The rooms would not comply with the BBR. The east and north parts have deep daylight penetration. A wider atrium and/or a lower "wing" of the surrounding building might improve the daylight performance.

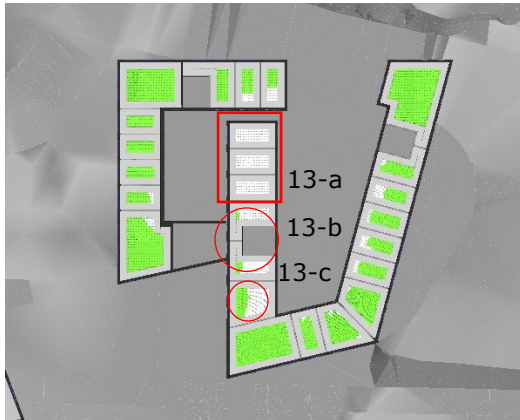
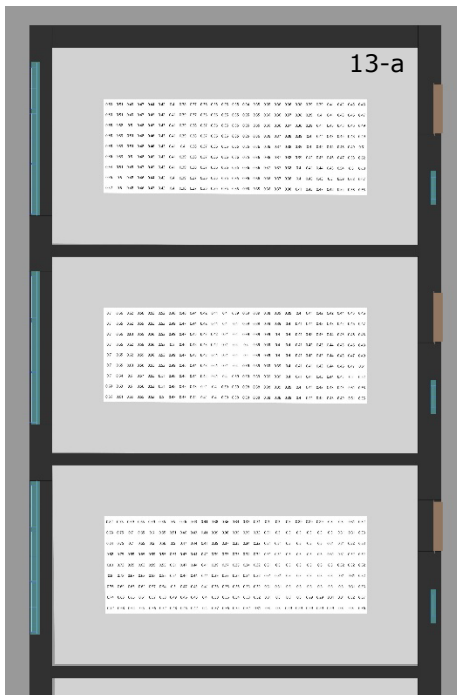
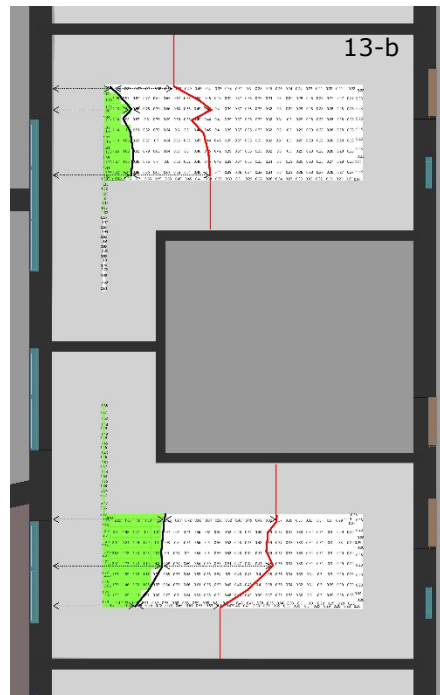
## Plan 13

13-a: Problematic in west part due to high obstruction. The rooms would not comply with the BBR. A wider atrium and/or a lower "wing" of the surrounding building might improve the daylight performance.

13-b: The area that has  $DF \geq 1\%$  is shown with green. The red line shows the maximum depth that the room would comply with the BBR.

First apartment: difficult to comply with the BBR.

In the second apartment: if hallway and bathroom are placed close to the entrance it will comply with the standard.

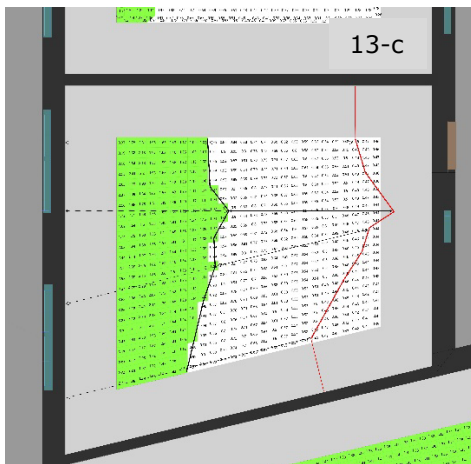
13-c: The area that has  $DF \geq 1\%$  is shown with green. The red line shows the maximum depth that the room would comply with the BBR. If hallway and bathroom are placed close to the entrance it will comply with the standard.

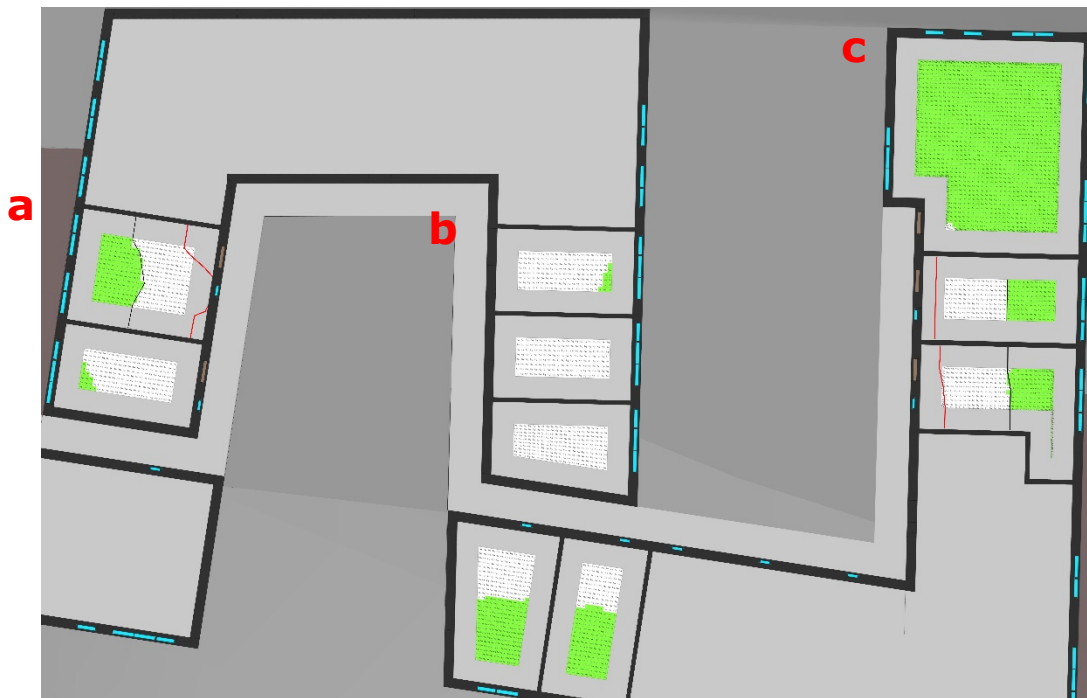
Plan 12.

a: The northern (upper) apartment will comply with the daylight requirement if occasionally used spaces are placed towards the entrance. The southern apartment does not have adequate daylight provision.

b: All three apartments do not meet the daylight requirements due to the building block shelf-shading.

c: The two apartments towards south can fulfil the daylight requirement if they consist of one open space/room that people are present other than occasionally.

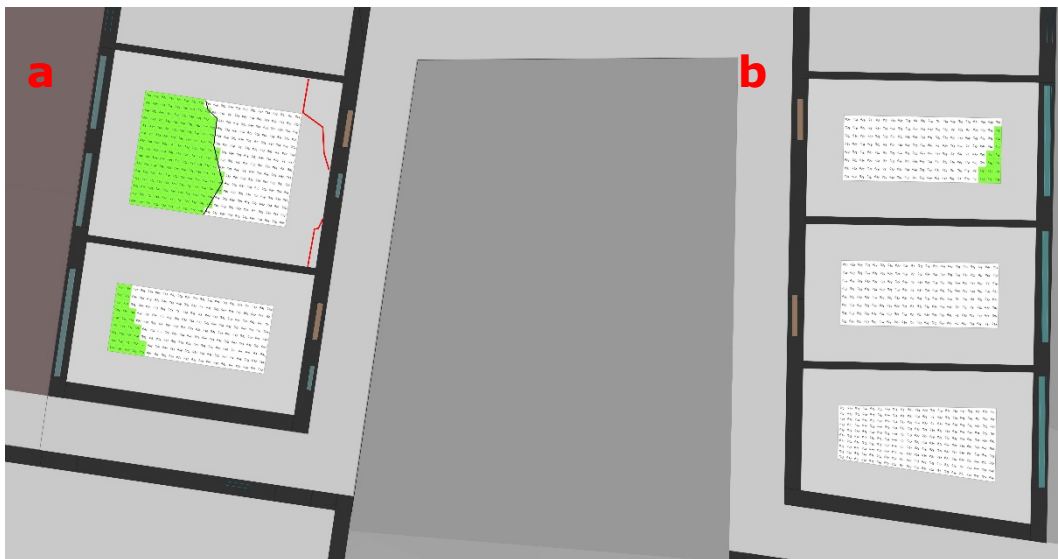
Plan 13

a: The northern (upper) apartment will comply with the daylight requirement if occasionally used spaces are placed towards the entrance. The southern apartment does not have adequate daylight provision.

b: All three apartments do not meet the daylight requirements due to the building block shelf-shading.

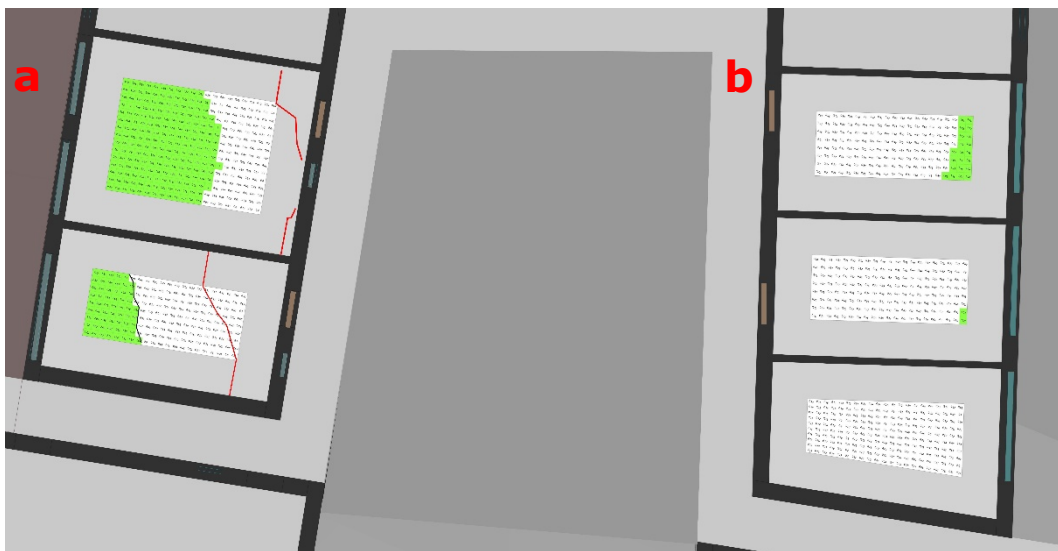
Plan 14

a: The northern (upper) apartment will comply with the daylight requirement if occasionally used spaces are placed towards the entrance. The southern apartment can fulfil the daylight requirement if it consists of one open space/room that people are present other than occasionally.

b: All three apartments do not meet the daylight requirements due to the building block shelf-shading.
